Small bridge, big success

Florida Keys bridge given another 20 years of life

BRIDGE RESCUE ARTICLE BY SARAH COLLINS, CPSM MAY 09, 2016

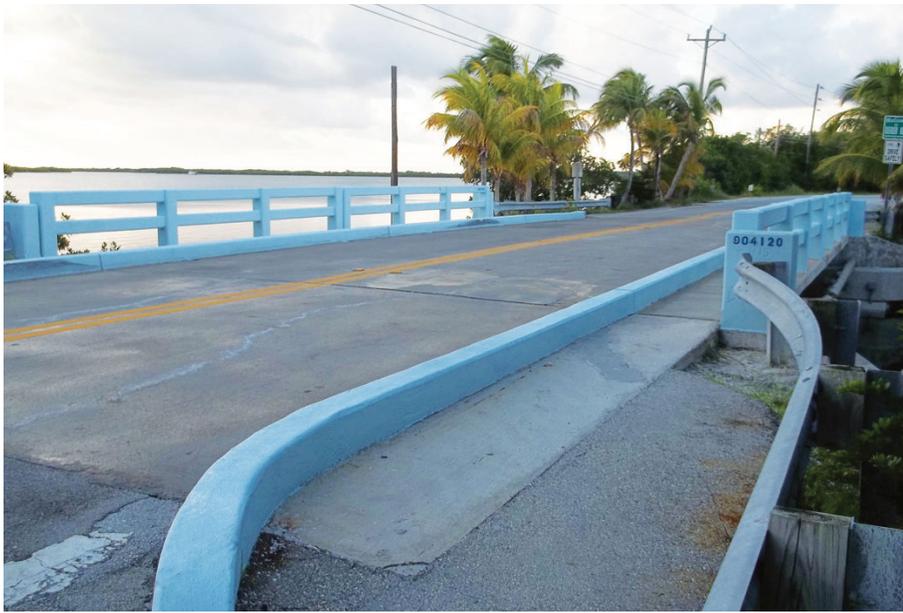
Even while faced with unexpected challenges, the pile jacket removal was completed without delay to the schedule or an increase to the budget. FDOT was pleased with the rehabilitation.

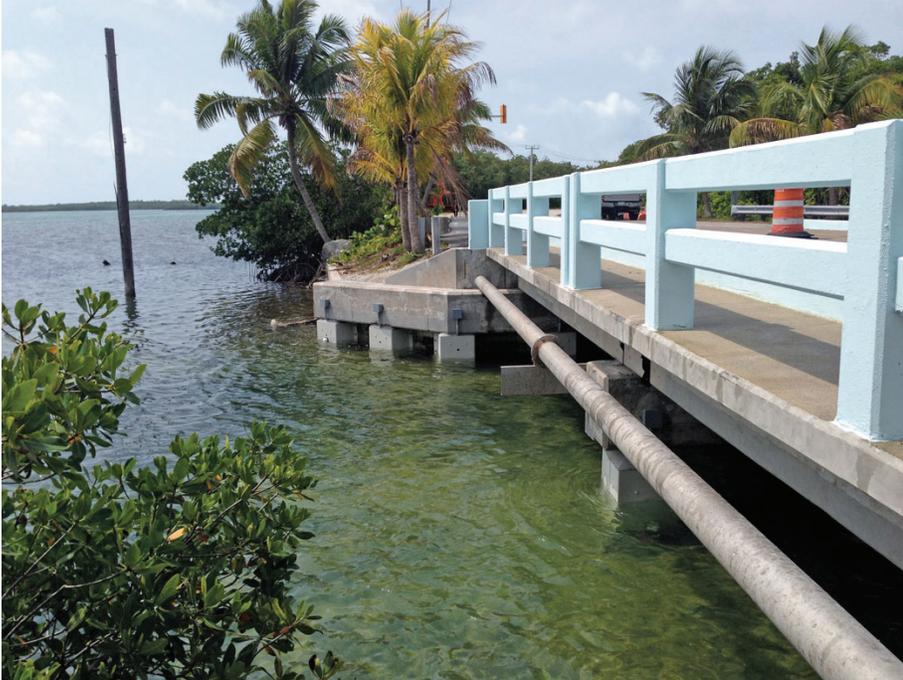
The Boca Chica Road bridge is skirted on both sides by shallow waters that are home or passageway to a large number of marine species.
